# **Proposed Changes to B2/AS1**

Report to Building Industry Authority  
November 2003

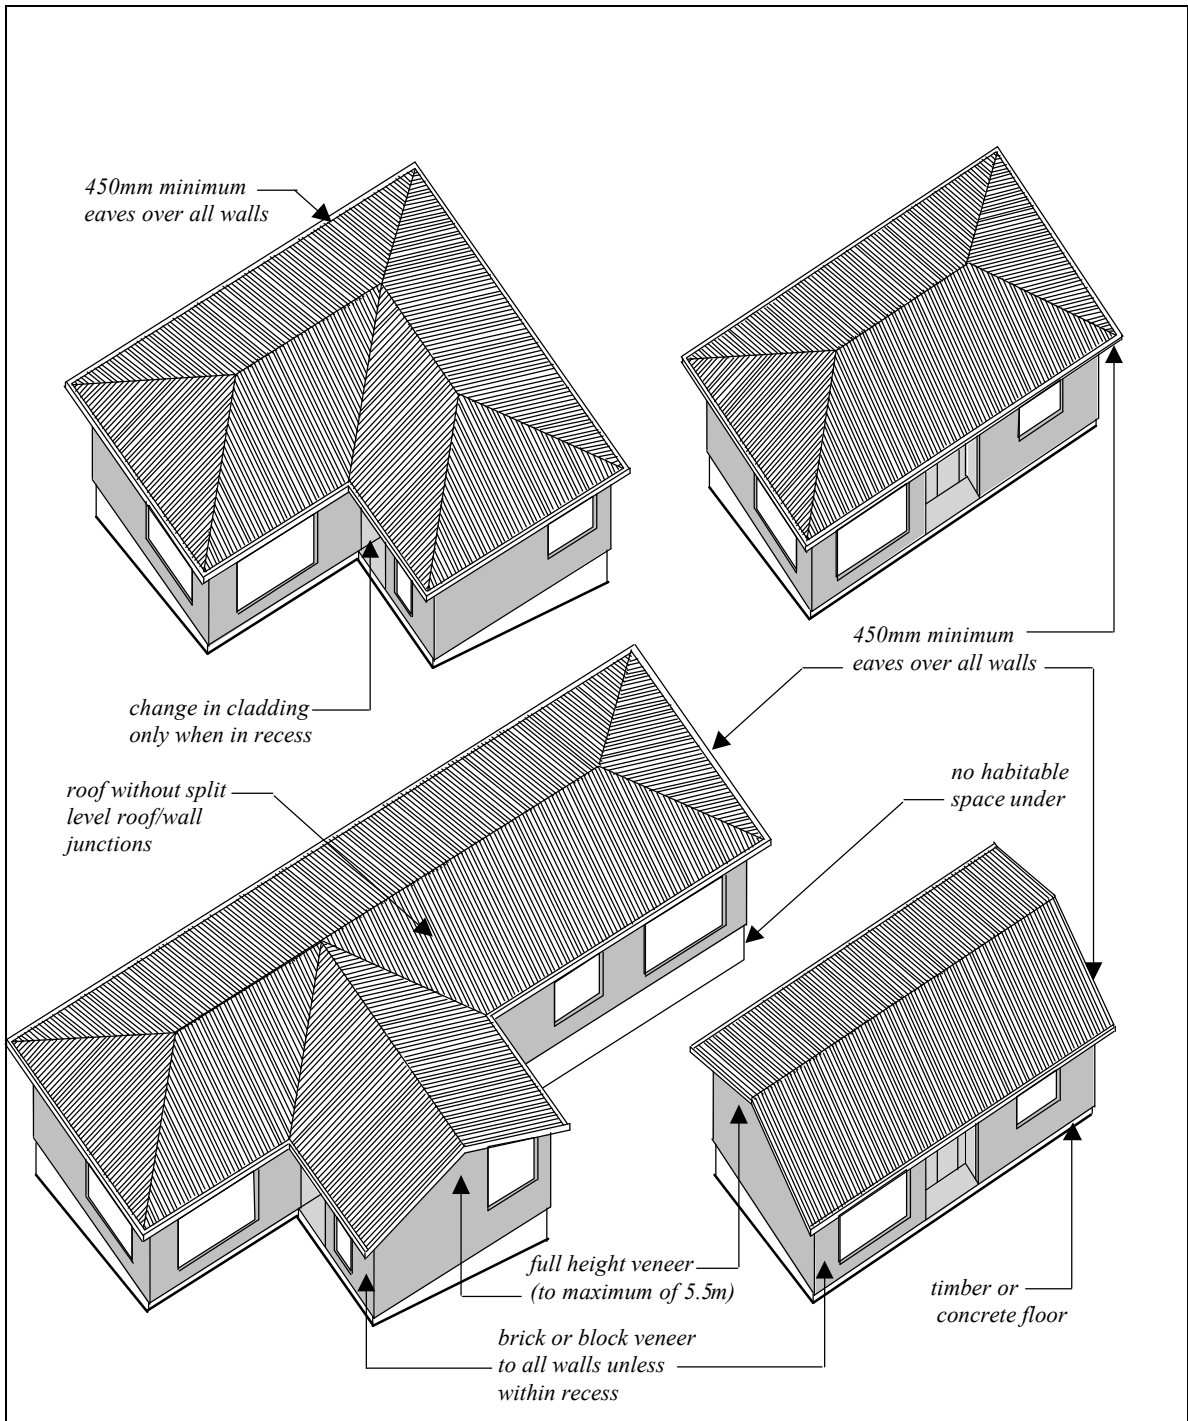
**Figure 1.1 Examples of Low Risk Masonry Houses**

It should be noted that these requirements make no distinction between untreated kiln dried radiata pine and Douglas fir, and that they allow the use of untreated kiln-dried radiata or Douglas fir framing in external walls for houses with masonry veneer cladding, provided they are low risk category – single storey with eaves and no complex features or junctions as shown in Figure 1.1.

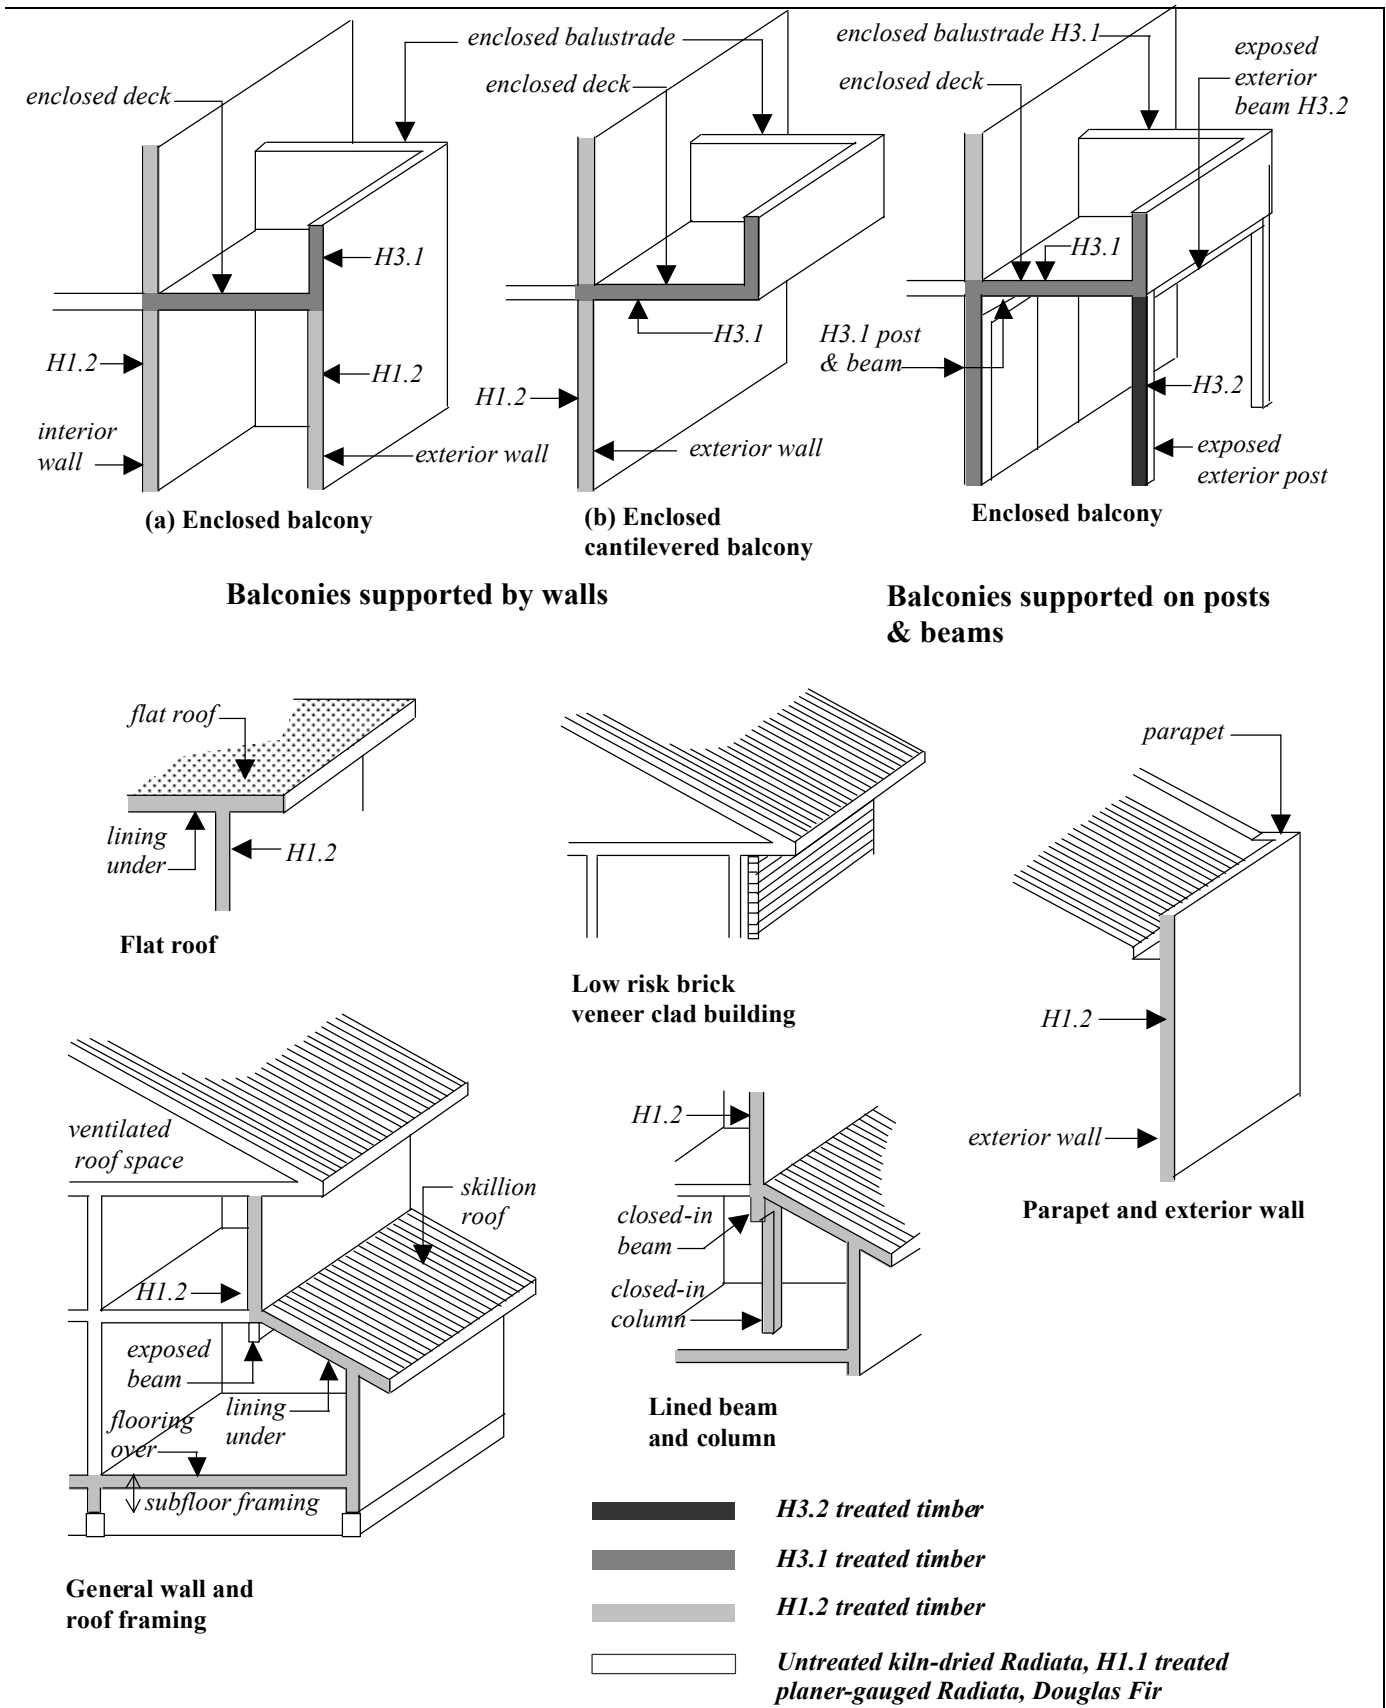
Figure 1.2 (a) – Required Treatment Levels for Timber Framing - by Location

Figure 1.2 illustrates the primary locations of the varying treatment levels recommended in this report.
